# **NORTH PULLMAN DISTRICT**

Chicago, Illinois

Preliminary Staff Summary of Information  
Submitted to the Commission on Chicago Landmarks  
February, 1992

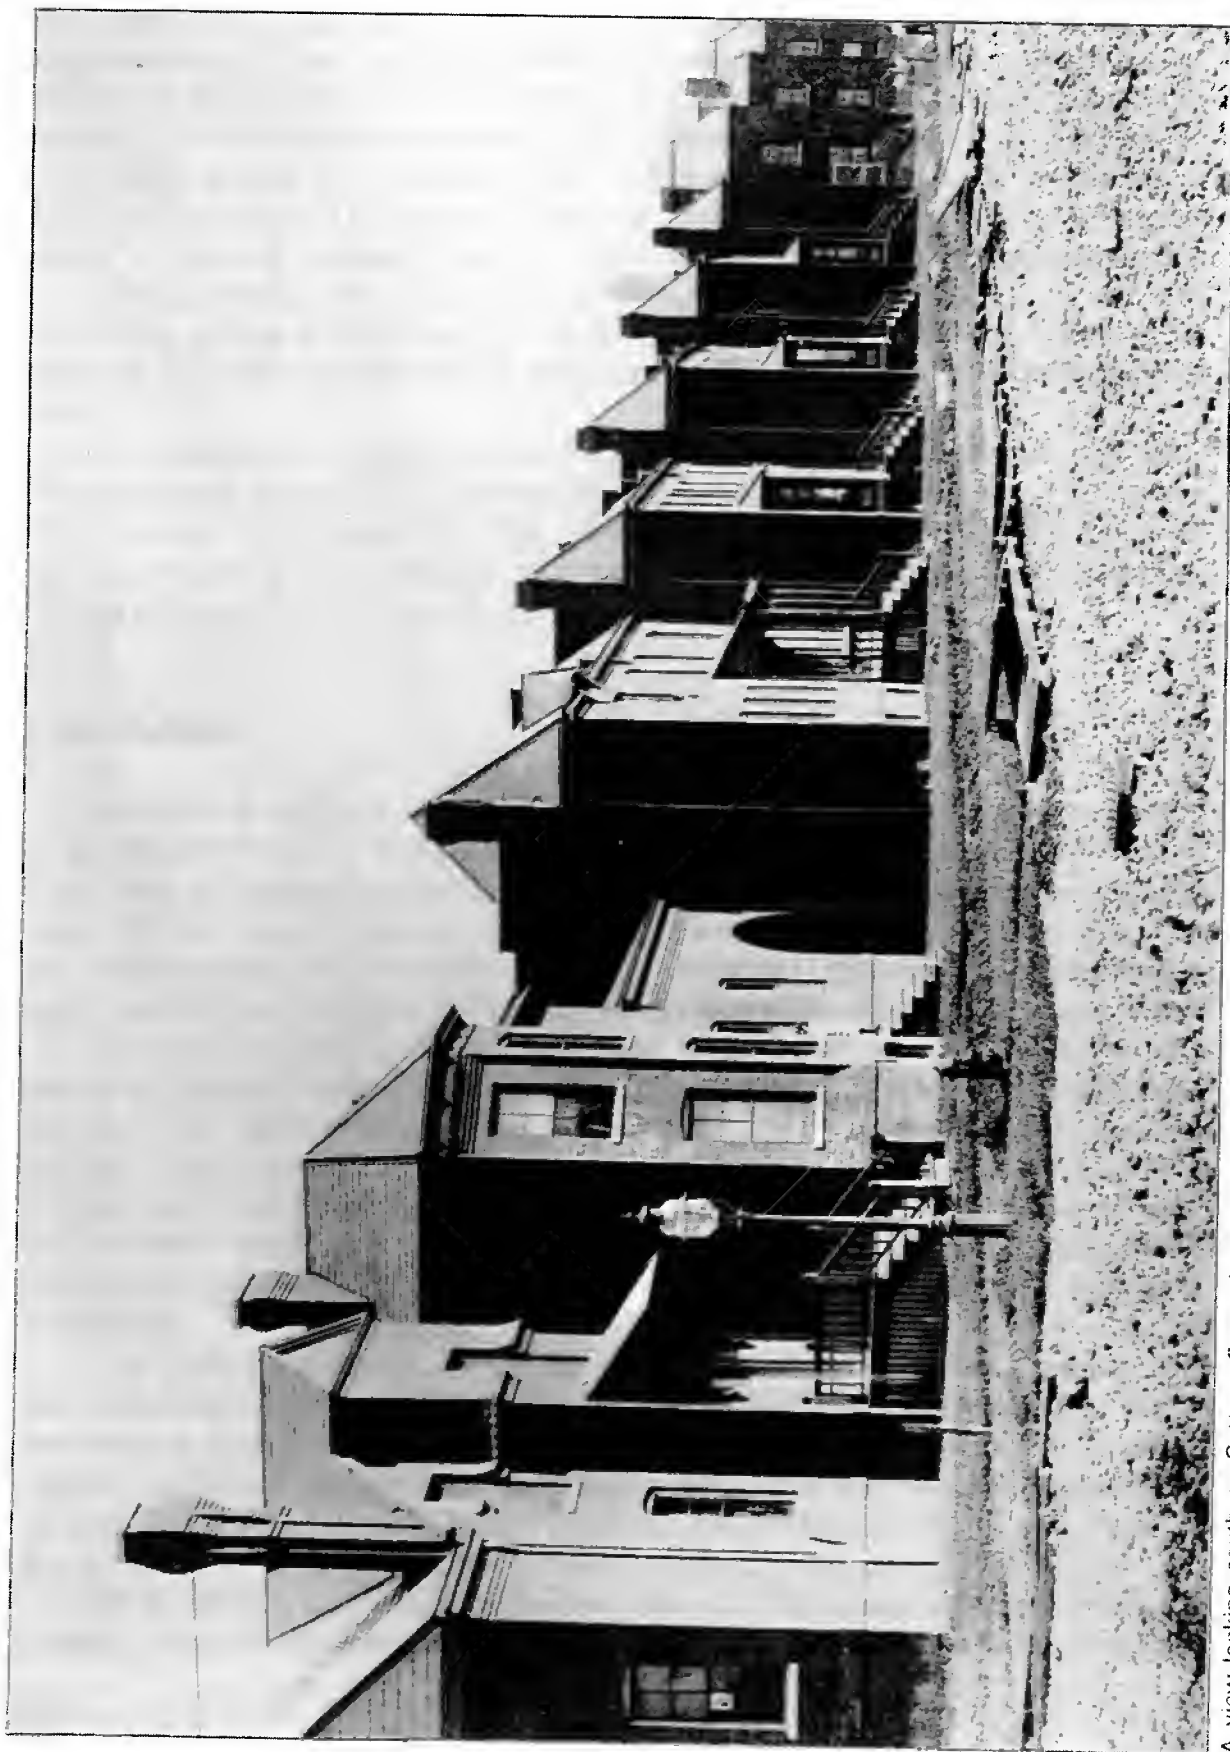
A view looking south on Cottage Grove Avenue at 107th Street, taken sometime during the late 1880s. These flat buildings, being situated on major thoroughfare, were more picturesquely detailed than comparable buildings to the west. *(Photograph by J. W. Taylor; courtesy of the Pullman Research Group)*

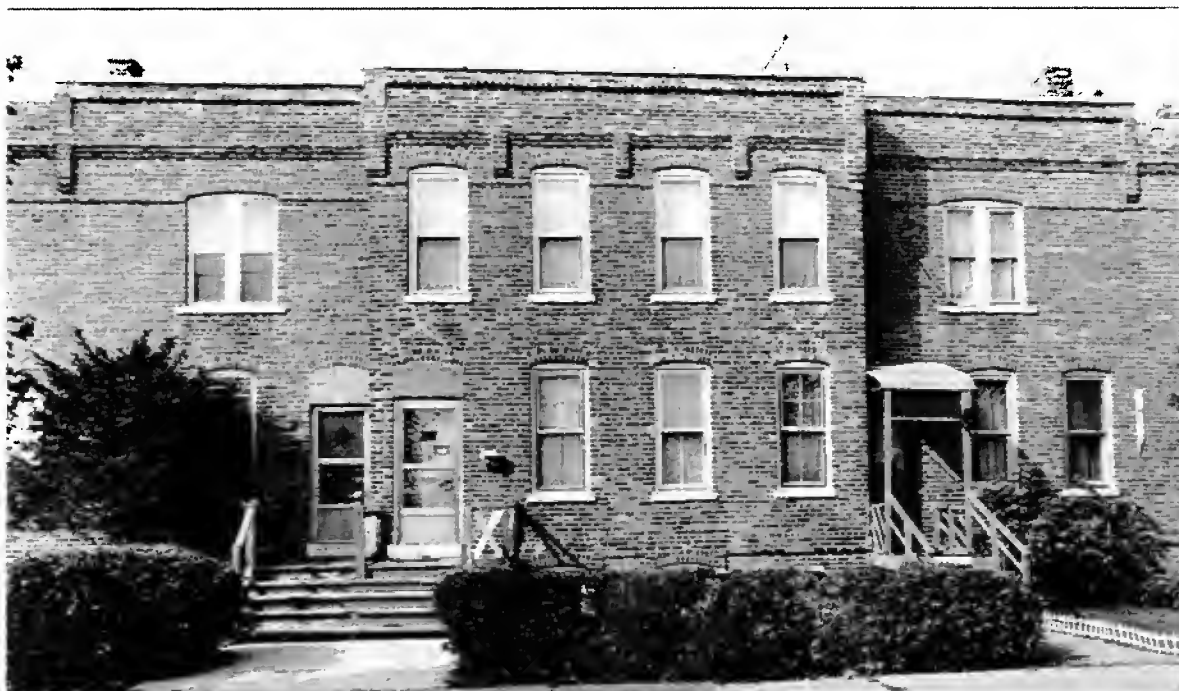
Single-family residences and two-flats (*center*) were built in units together, such as these at 10732 through 10736 South Langley Avenue. These units built in 1884-85 have a minimum of ornamentation. (*Gwen Sommers Yant, photographer*)

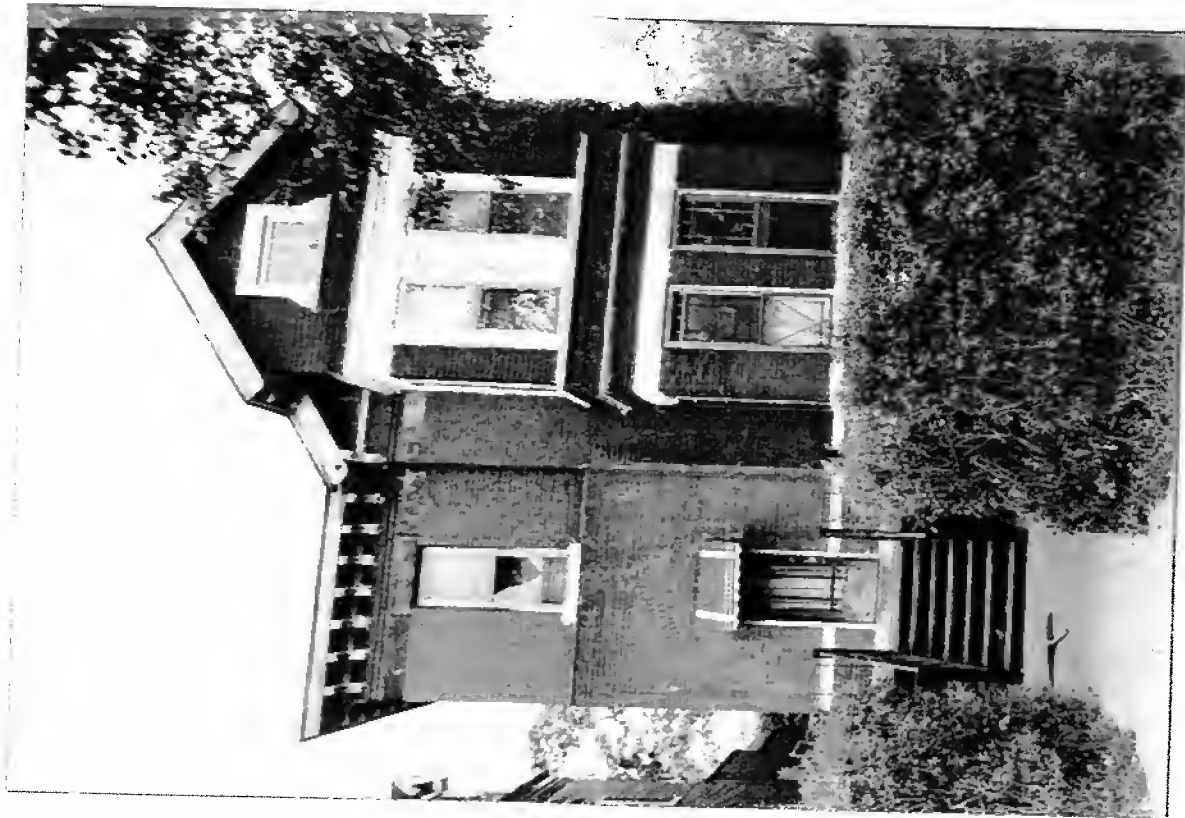
Although built for rental to executives of the Allen Paper Car Wheel Company, the single-family house at 10757 South Cottage Grove was actually shared by several tenants. (Gwen Sommers Yant, photographer)

The similarity of design and detailing of the house at 10757 Cottage Grove with the large executive houses built on 111th Street in South Pullman suggest it was likely built for rental to the higher salaried officials of the nearby Allen Paper Car Wheel Company. However, listings in the 1887 Pullman directory show that in fact occupancy of this house was shared by several residents, including some who were identified as "boarders." The other executive house, now demolished, stood on the corner lot at 108th Street and, according to the same directory, was occupied by one of the executives of the Allen works.

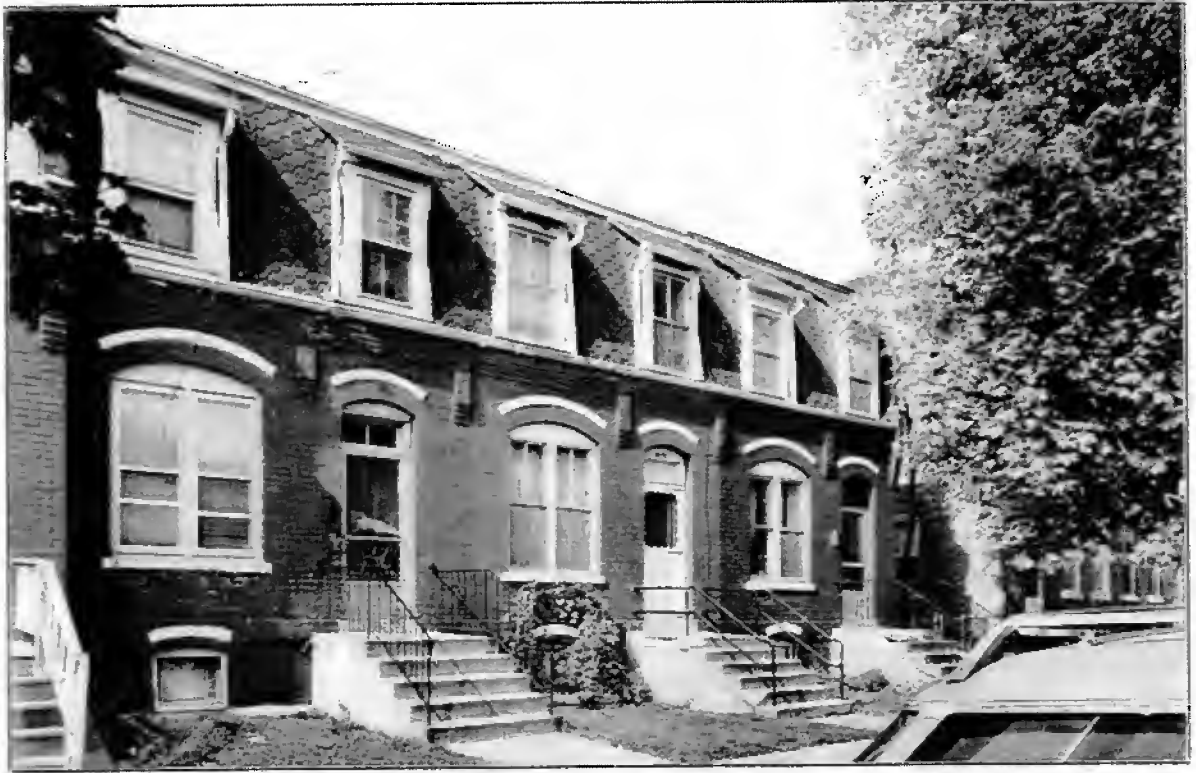
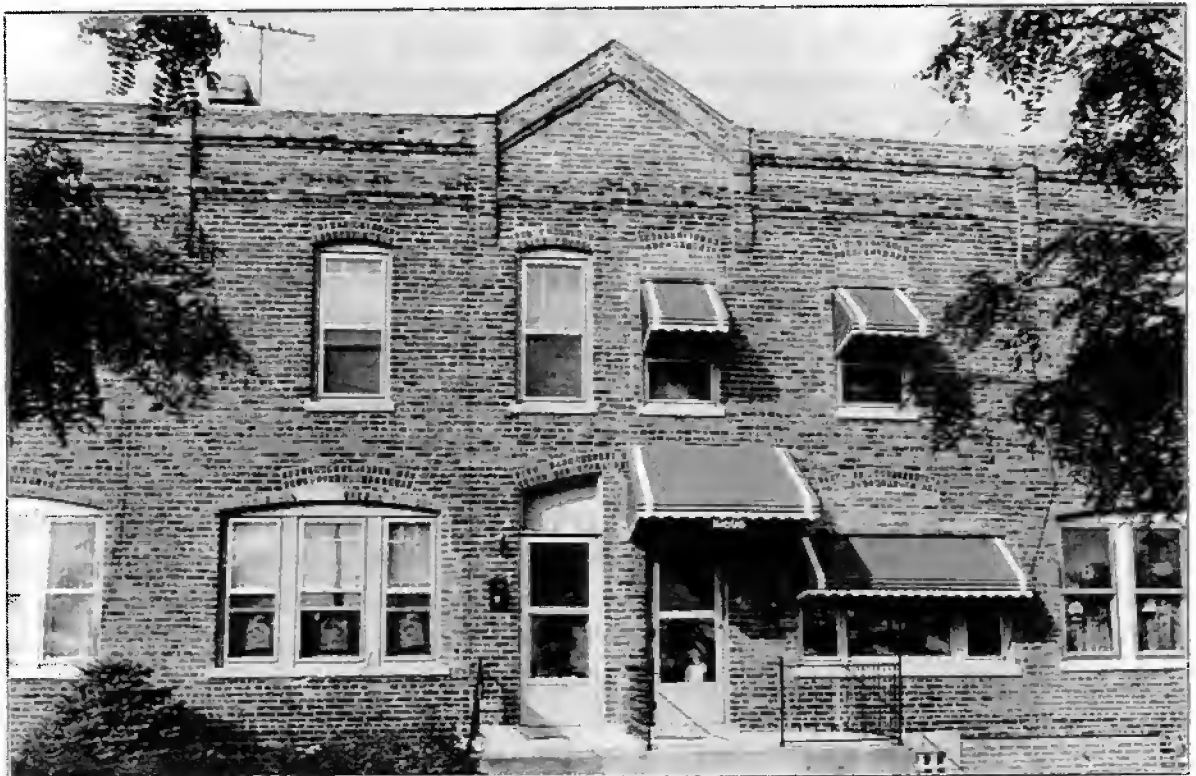
The houses built during the initial phase of construction, 1880 to 1882, such as at 10748-54 South Champlain (*above*) had more intricate detailing than those built during the second building push in 1884-85, as illustrated by 10608-10 South Langley (*below*). (Photographs by Gwen Sommers Yant)

The oldest homes in these two blocks are those in the south half of the 10700-block. The units from 10742 through 10772, on the west side, and from 10741 through 10775, on the east, are symmetrically arranged, with duplexes flanking groups of single-family homes. On the west side, the two-flat duplexes on either end are faced with orange brick and have black-trimmed segmental arched window and door openings and brick corbelling at the parapet. The nine two-story, single-family rowhouses have picturesque mansard roofs with shed dormers and corbelled brickwork similar to that of the duplexes. These homes, which are among the best intact examples of the original domestic architecture in Pullman, are comparable to ones in the 11300-block of South Champlain Avenue.

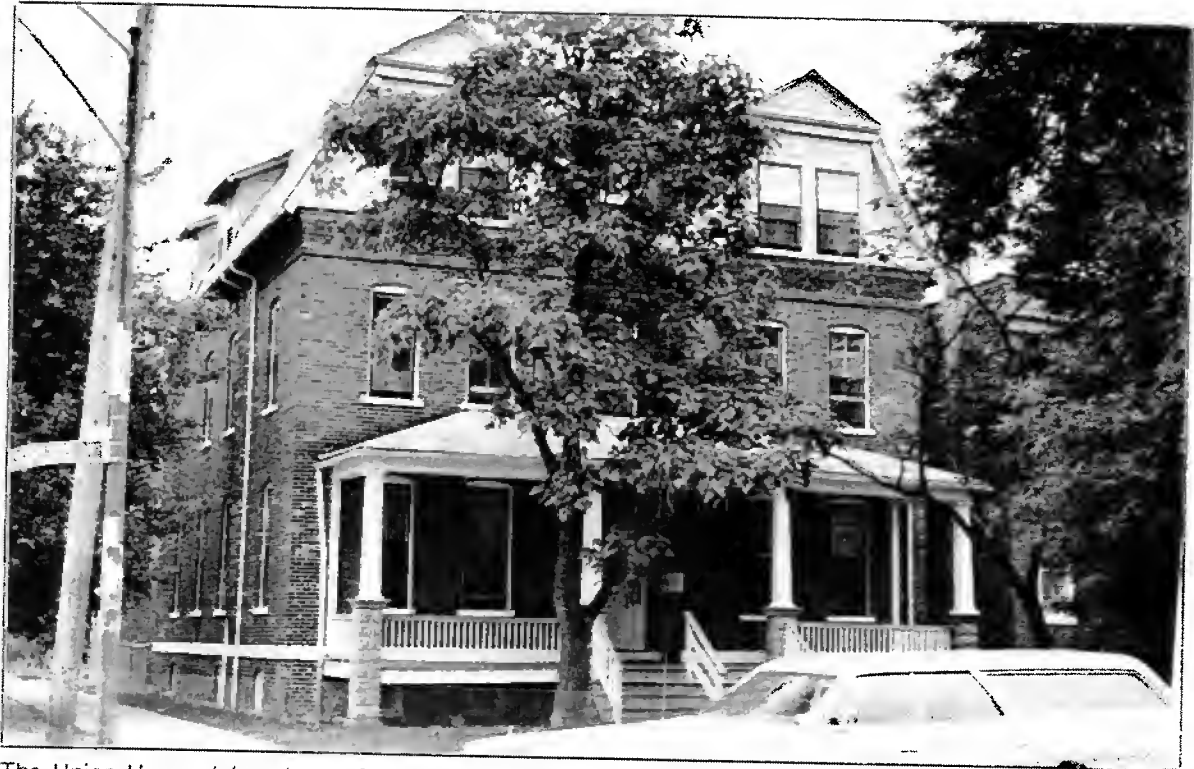
The Union House (*above*), at 10401-03 South Corliss Avenue, was North Pullman's counterpart to the Florence Hotel in South Pullman. (*Gwen Sommers Yant, photographer*)

The hotel, as indicated in the advertisement below, accommodated both transient and semi-permanent guests, including a number of employees of the nearby Union Foundry. (*Pullman Directory, 1883*)

The demand for housing in these blocks was great due to the neighboring the Union Foundry. Boarding houses anchored each end of the 10400-block. The Union House, at 10401, was an popular hotel and boarding house. Unlike the company-run Florence Hotel, the Union House was privately leased and operated, catering to both transient and permanent guests. Directory listings for 1883 indicated that the building must have been filled to capacity, listing thirty permanent residents. Most of these were employees of the Union Foundry. The Union House is a three-story brick structure, with distinctive twin gambrel roofs. The flats and houses on the block are grouped in pairs. Except for the three-flats at 10409-11, all of the buildings are two stories tall. As compared with other designs, these have significantly more detailing, including in some cases the orange and black trimmed brick that is characteristic of the initial construction. All of the structures in the 10400-block were built prior to 1883.

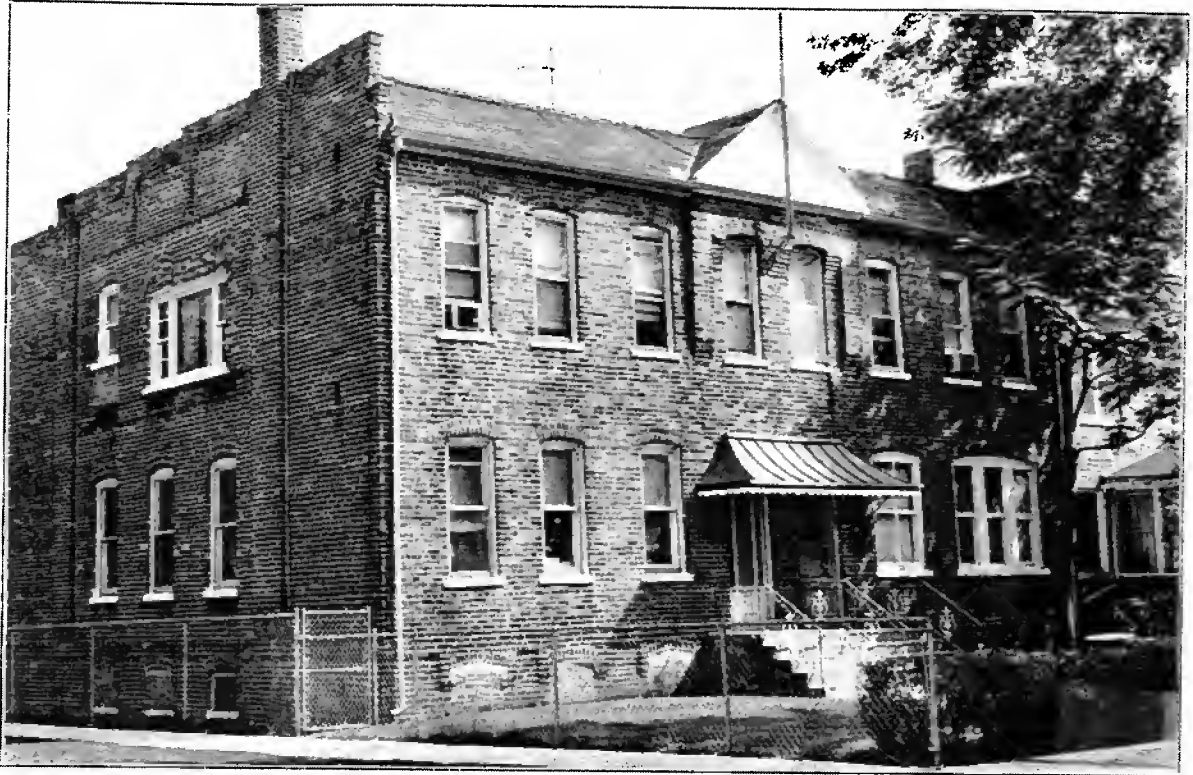
Within the North Pullman area, structures used for non-residential purposes were designed to resemble residential ones. The design of the former 105th Street School (*above*) at 10501-03 South Corliss Avenue is comparable to that of paired two-flats. The structure at 10511-13 South Corliss (*below*) was modified with the addition of a new doorway for the grocery that was located in the building. (*Gwen Sommers Yant, photographer*)
